## STONE BUILT SHEEPWASHES IN GLOUCESTERSHIRE

*John V. Garrett and Ted Hodgkins*

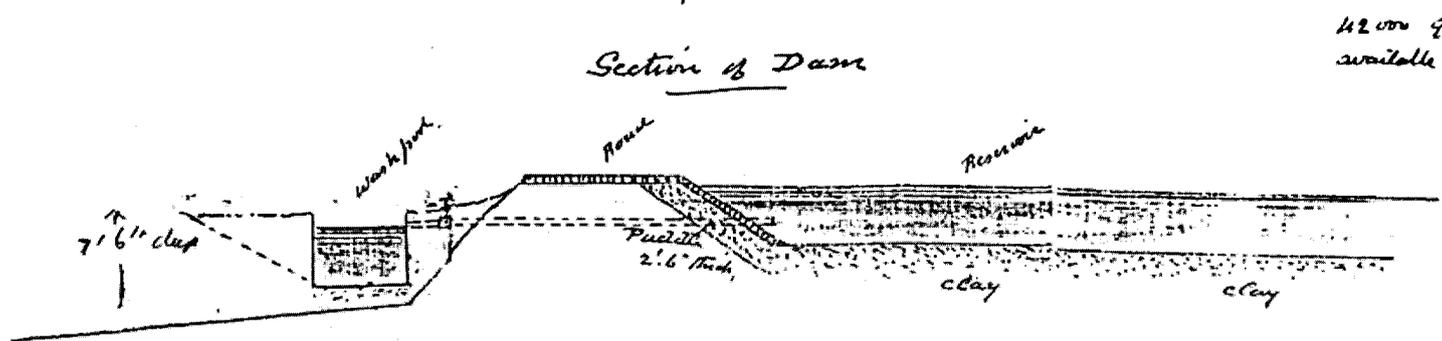
Fig.1. Part of the drawing for the construction of the sheepwash on Cleeve Common 1896.  
(by permission of the Board of Conservators)

This is probably the best known of the sheepwashes as it is on the Cotswold Way. It is the only one for which documentary evidence of construction exists. It was ordered to be built by the Board of Conservators of Cleeve Common in 1896. A drawing of the details of construction exists and part is shown at figure 1. It is interesting to note that the cost of construction was £89.18s. 10d. and it was for the use of commoners only.

The drawings show that a dam was made across the head waters of the Isbourne in Watery Bottom, Cleeve Common, to create a small pond of water. The washpool, below the pond, (Fig. 2), is 10 feet in diameter and is made of ashlar limestone blocks with a sloping ramp. The stones were set in cement with a clay puddle backing to keep the pool water tight. Water was admitted from the pond by an iron pipe controlled by a valve and allowed to flow out freely by overflow. The pool could be drained by another pipe and valve. Mr. Witts, civil engineer of Cheltenham, advised on its construction. It must have been one of the last, perhaps the last, sheepwash to be built, and was in use until at least the mid 1930s. A description of the wash in use is to be found in a 1919 book by J. H. Garrett *From a Cotswold Height*. (3). Figure 3 shows sheep being washed there before 1919. The wash has recently been repaired and fenced by the Cotswold Warden Service.

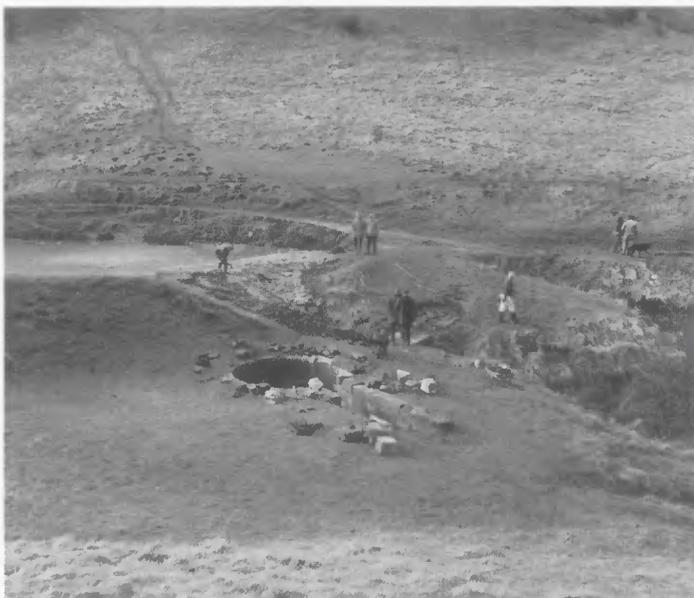
Fig 2. General view of Cleeve Common sheepwash undergoing repair 1994

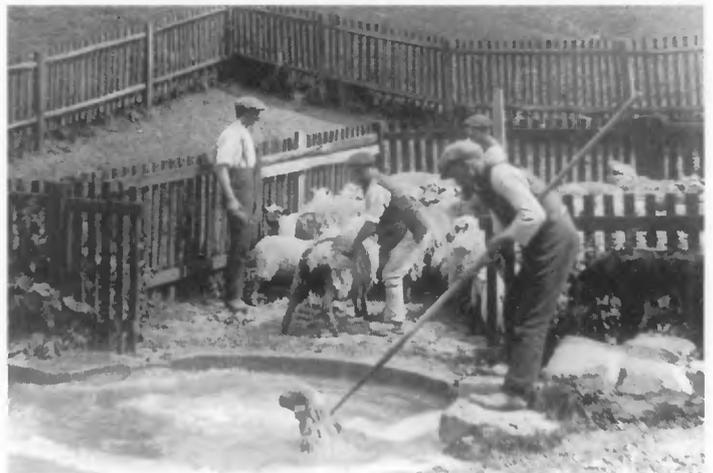
Fig 3. Cleeve Common sheepwash in use before 1919

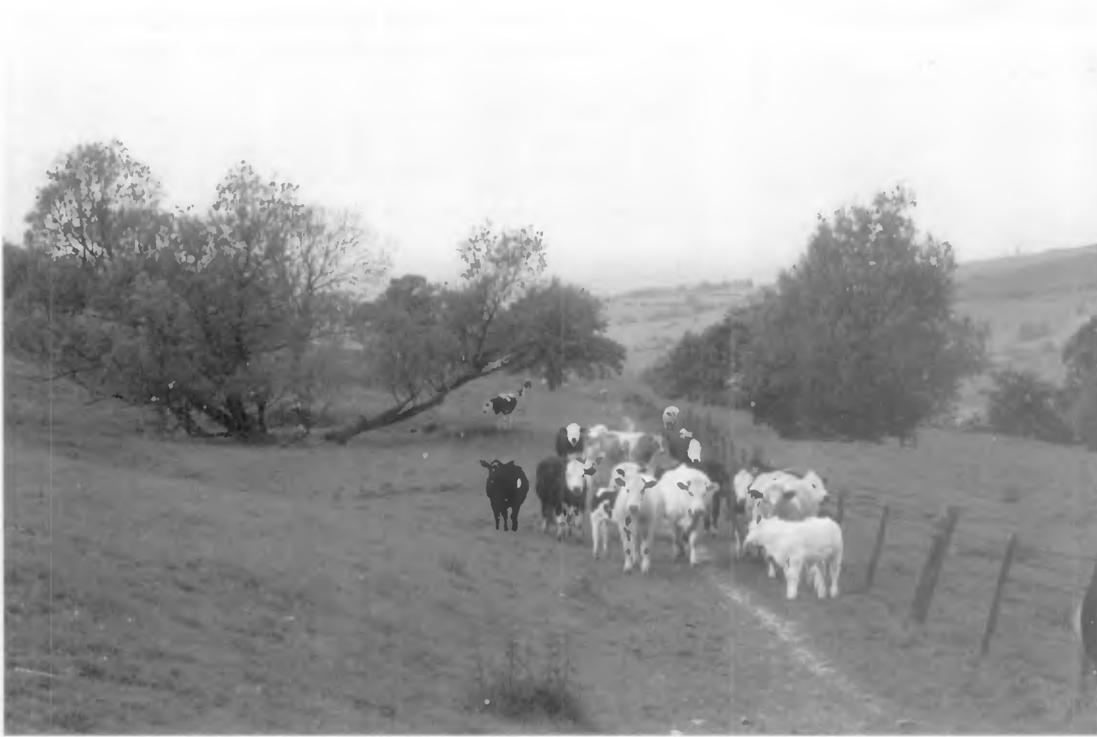
Fig 4. General view of sheepwash complex in Prescott Park. Trees on left of the track are in silted up pool. Those on the right are in the sheepwash

This is a specially interesting sheepwash complex of collecting pond, dam and wash. Without prior knowledge of its existence derived from the 25 inch plan it would now be difficult to identify. (Fig 4)

The pond and dam lie on the west side of the bridleway from Wickfield Farm, formerly Prescott Hill Farm, to Prescott and Pardon Hill. It is silted up with a willow tree growing beside the low dam. It collects water from springs higher up the slope brought to it by a channel probably at least partly artificial. The washpool itself lies on the other side of the bridleway. Some ashlar blocks are still visible. What appears to be the ramp leads down hill. This complex is well known to the local farmer who states it has not been used in his or his father's time. The construction he expects to have been not later than the mid 19th century. This elaborate complex, which must have cost a considerable amount of time and labour, illustrates how important it was to have a sheepwash at that time.

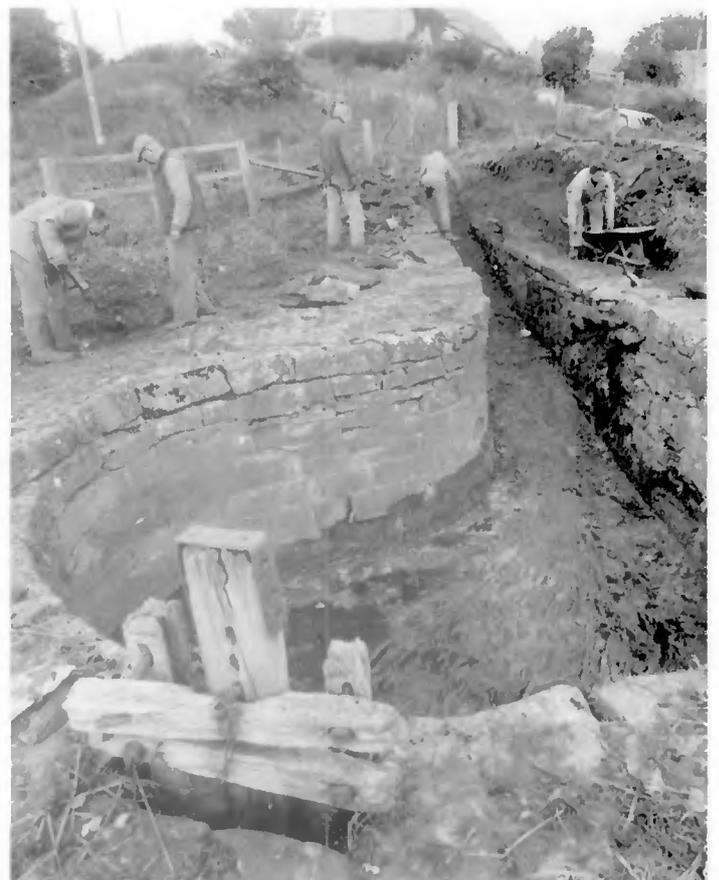
Fig 5. Cutsdean sheepwash being repaired

This is a fine example of a stone built circular, or rather banjo, shaped sheepwash with escape ramp (Fig.5). Recently restored by local residents and the Cotswold Warden Service, it is described in Margaret Westerling's book of 1939, *Countryside Contentments* (4) where it is said to have been in use for weeks at a time before 1914.

Water was admitted to the basin by a pipe from the strong spring just across the road and its outflow was controlled by a wooden sluice in the lower side of the pool. The basin is about 12 feet in diameter and 5 ft 6 inches deep. The basin is made of fine ashlar blocks, the ramp of rubble stones. An architect's

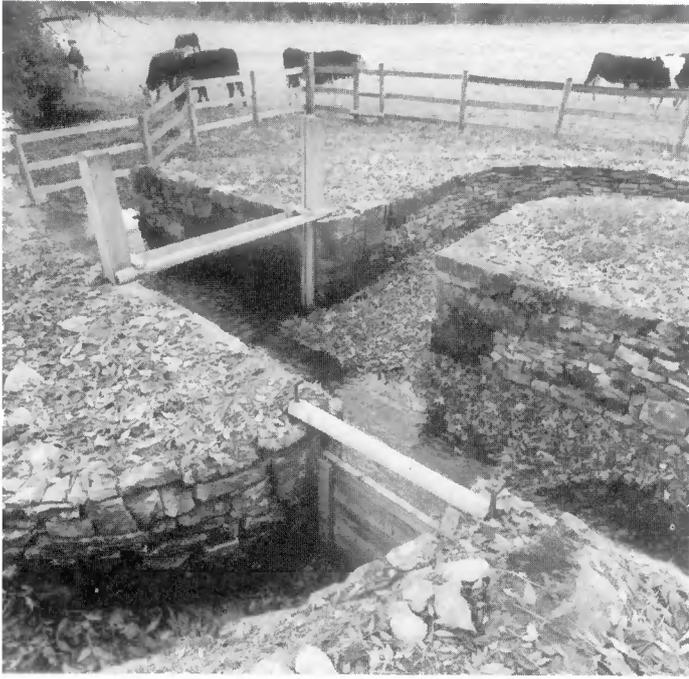
Fig 6. Baunton sheepwash reinstated 1994

Two wooden sluices control the level of the water in the wash and a sloping escape ramp leads into the west meadow. Further upstream another sluice directs water into the leet leading to Trinity Mill, enabling the sheepwash to be isolated during use. During 1994 the whole structure was renovated by the Cotswold Voluntary Warden Service after removal of several trees which were growing in the walls. (Fig. 6)
